# Distant Harrington rod migration 35 years after implantation

Robert K. Lark<sup>a</sup>, Adam M. Caputo<sup>a,\*</sup>, Christopher R. Brown<sup>a</sup>, Keith W. Michael<sup>a</sup>, Julie K. Thacker<sup>b</sup>, William J. Richardson<sup>a</sup>

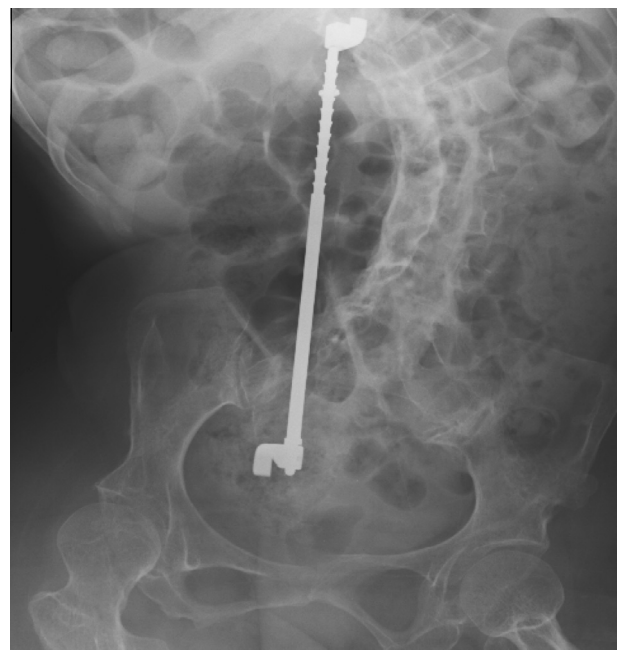
**Fig. 1.** Anteroposterior plain radiograph of the abdomen demonstrating distal migration of the Harrington Rod.

Plain radiographs were obtained (Fig. 1) which revealed distal migration of the Harrington rod. A CT scan confirmed migration and raised concern for hardware penetration of the bowel. The patient was therefore admitted with plans for surgical removal of the hardware. Flexible sigmoidoscopy was used to examine the suspected site of perforation. Direct visualization of the rectum revealed frank perforation by the rod with an associated ulceration ten centimeters proximal to the anal verge (Fig. 2).

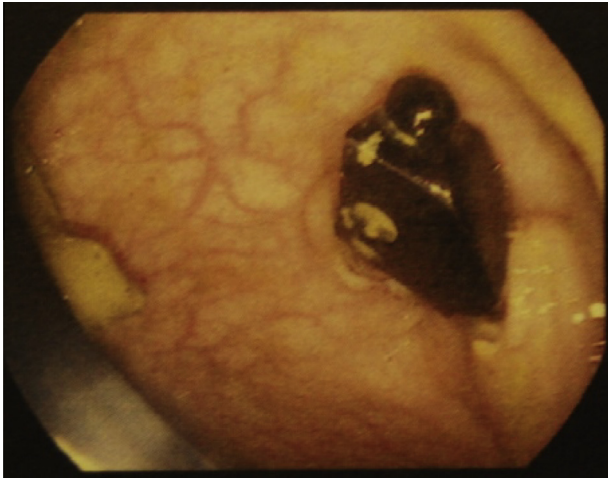
**Fig. 2.** Direct visualization via sigmoidoscopy of the distal rod and hook penetrating the rectum. (For interpretation of the references to colours in this figure legend, the reader is referred to the web version of this paper.)

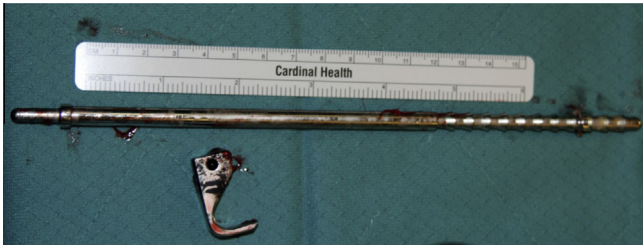
**Fig. 3.** Harrington rod and distal hook after removal. (For interpretation of the references to colours in this figure legend, the reader is referred to the web version of this paper.)

Using rigid endoscopy, the rod and distal hook were grasped with a long pituitary rongeur and removed transanally. There was no pus or fluid expressed with removal of the hardware (Fig. 3). Subsequently, a laparoscopic diverting loop colostomy
