"Mini-Superfund" Site in Kawerau, New Zealand: A Closer Look at Water Quality

May 2008

Masters project submitted in partial fulfillment of the requirements for the Master of Environmental Management degree in the Nicholas School of the Environment and Earth Sciences of Duke University
2008

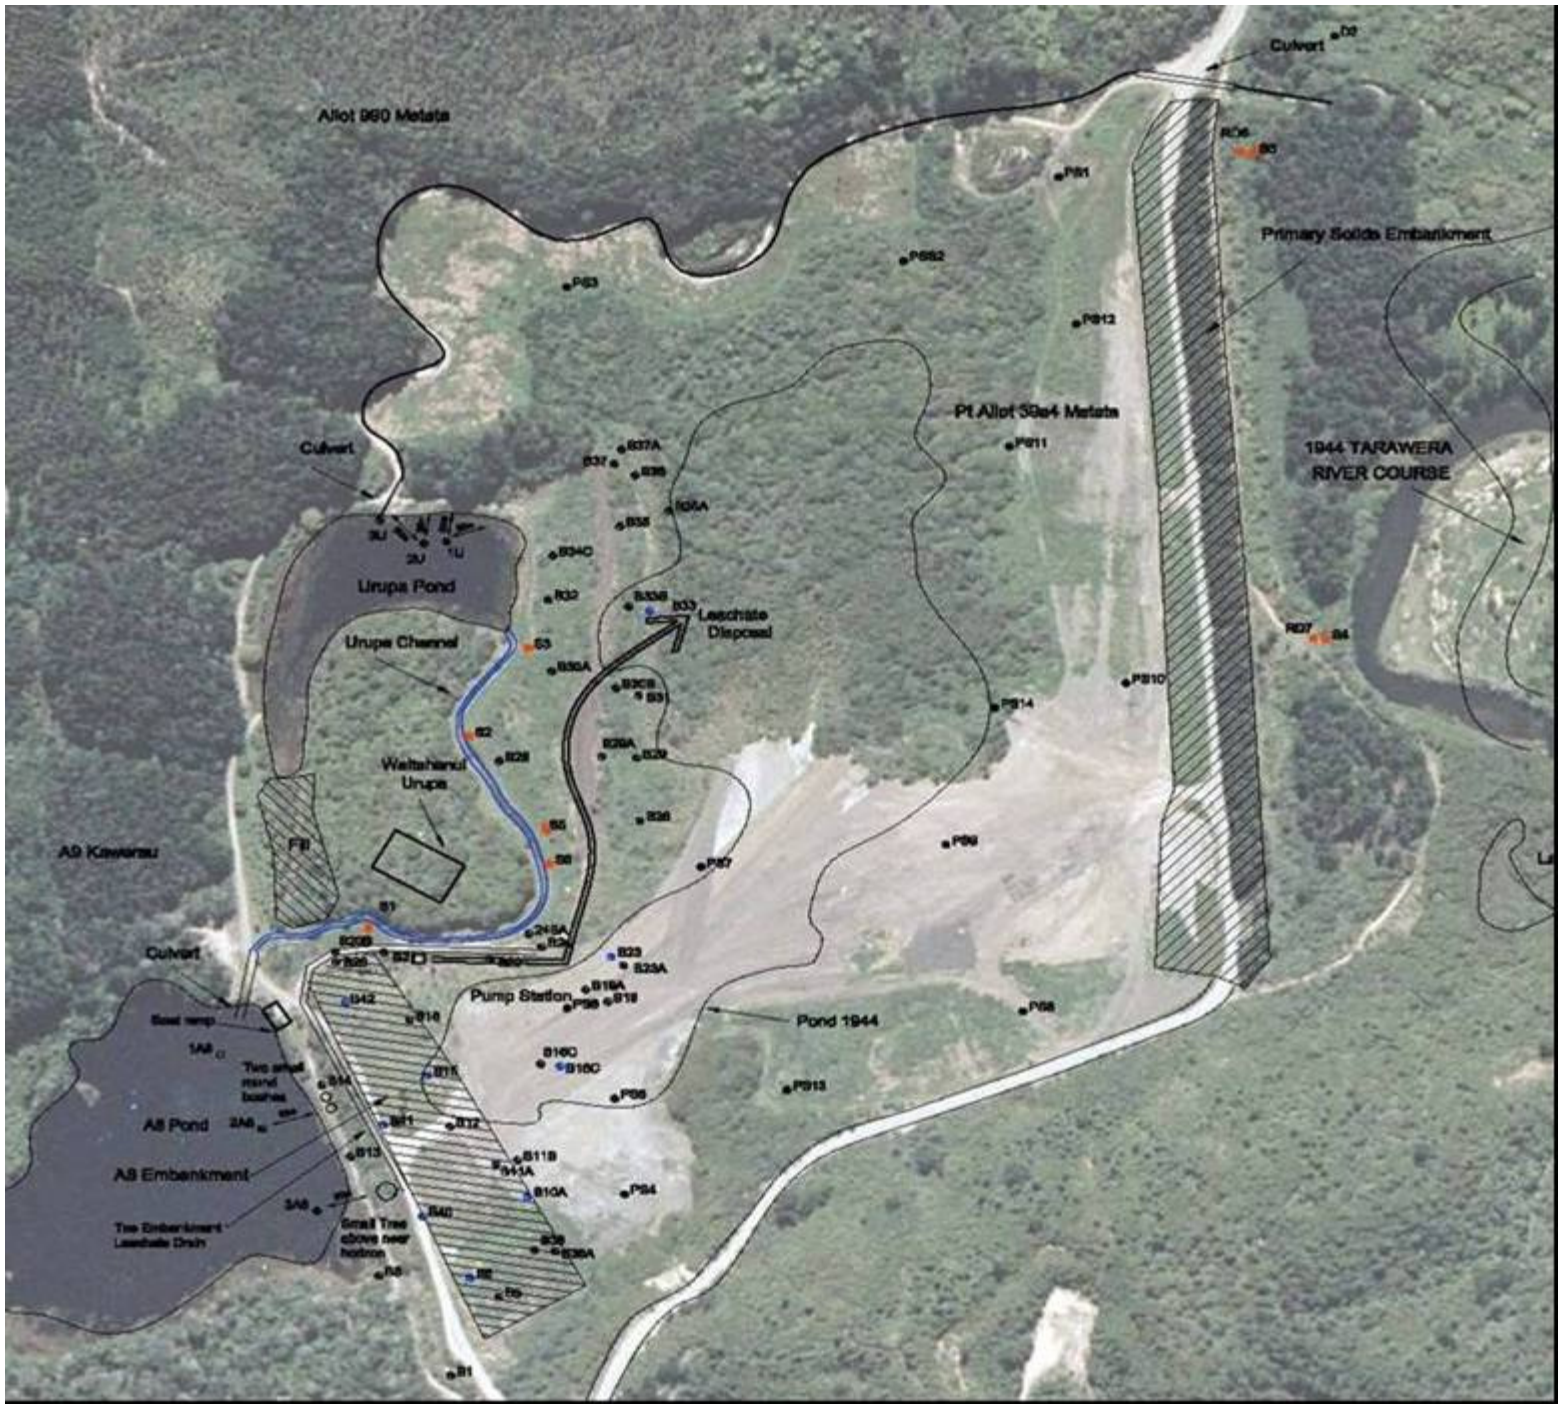
Figure 2. Aerial View of Waste Disposal Site and Surrounding Area

Tasman Pulp and Paper Mill is located approximately 300 meters to the east of the Tarawera River in Kawerau, Bay of Plenty, New Zealand (see Figure 1). Figure 2 shows an aerial view of the primary solids waste site and the surrounding area including the Te Wai U o Tuwharetoa spring (TWT spring), A8 pond, A8/Western Embankment, Upper Embankment, Urupa pond, primary solids disposal area, Primary Solids/Eastern Embankment, and the Tarawera River. This figure does not illustrate the locations of the pulp and paper mill processing plants or aeration ponds (used to treat liquid waste).

The former Lake Rotoitipaku is shown in Figure 2 and can be identified by the label "Pond 1944". The solid waste disposal site for the Tasman Pulp and Paper Mill is located several kilometers to the northwest of the Mill in Kawerau and approximately 3 kilometers to the west of the Tarawera River. This disposal area is not specifically labeled in Figure 2 but is located towards the southern end of the valley that contains the waste disposal area and is distinguishable by its tan color. Constructed embankments in the west (up gradient) and the east (down gradient) enclose the solid waste disposal area.

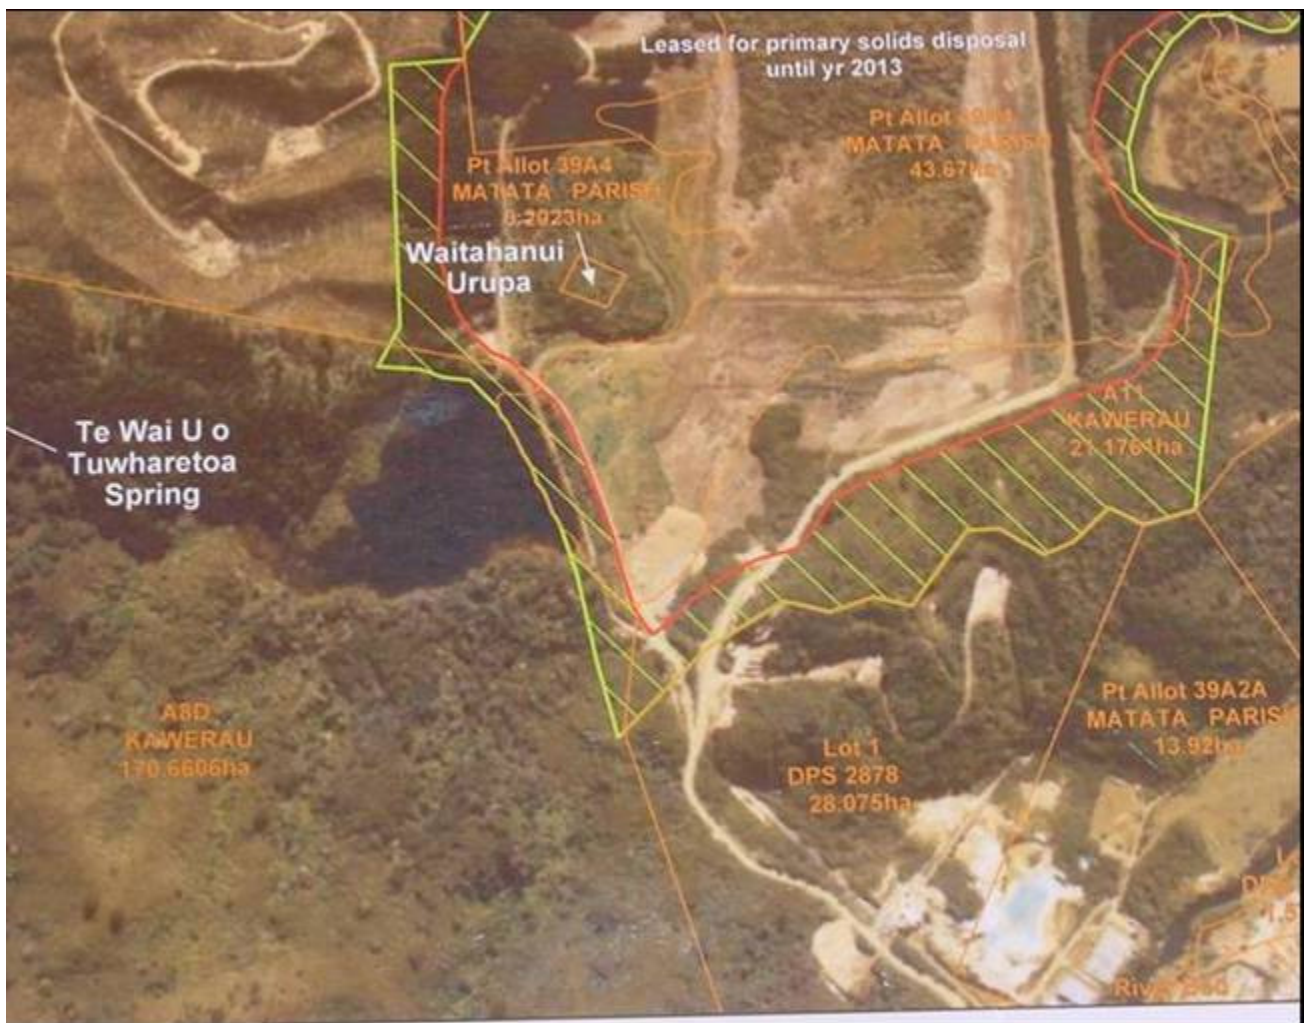
Figure 3. Kawerau A8, 39 A4, and A11 Land Plots

Figure 3 below provides a schematic leased land and neighboring land blocks. A Maori Board of Trustees leases land blocks 39A4, A11, A9, and 990 in Kawerau, New Zealand to Norske Skog Tasman Ltd (NST). Except for land blocks A9 and 990, these blocks are shown in Figure 3. Since 1971 land block 39A4 has been used for waste disposal from the Tasman pulp and paper mills, which is owned by NST. Although land block A8 has not been leased to NST, NST built an artificial embankment along the eastern boundary of the A8 land block to prevent solid waste from encroaching on that A8. Despite these efforts, preliminary sediment and surface water analysis in this pond suggests that contamination has spread to land block A8.

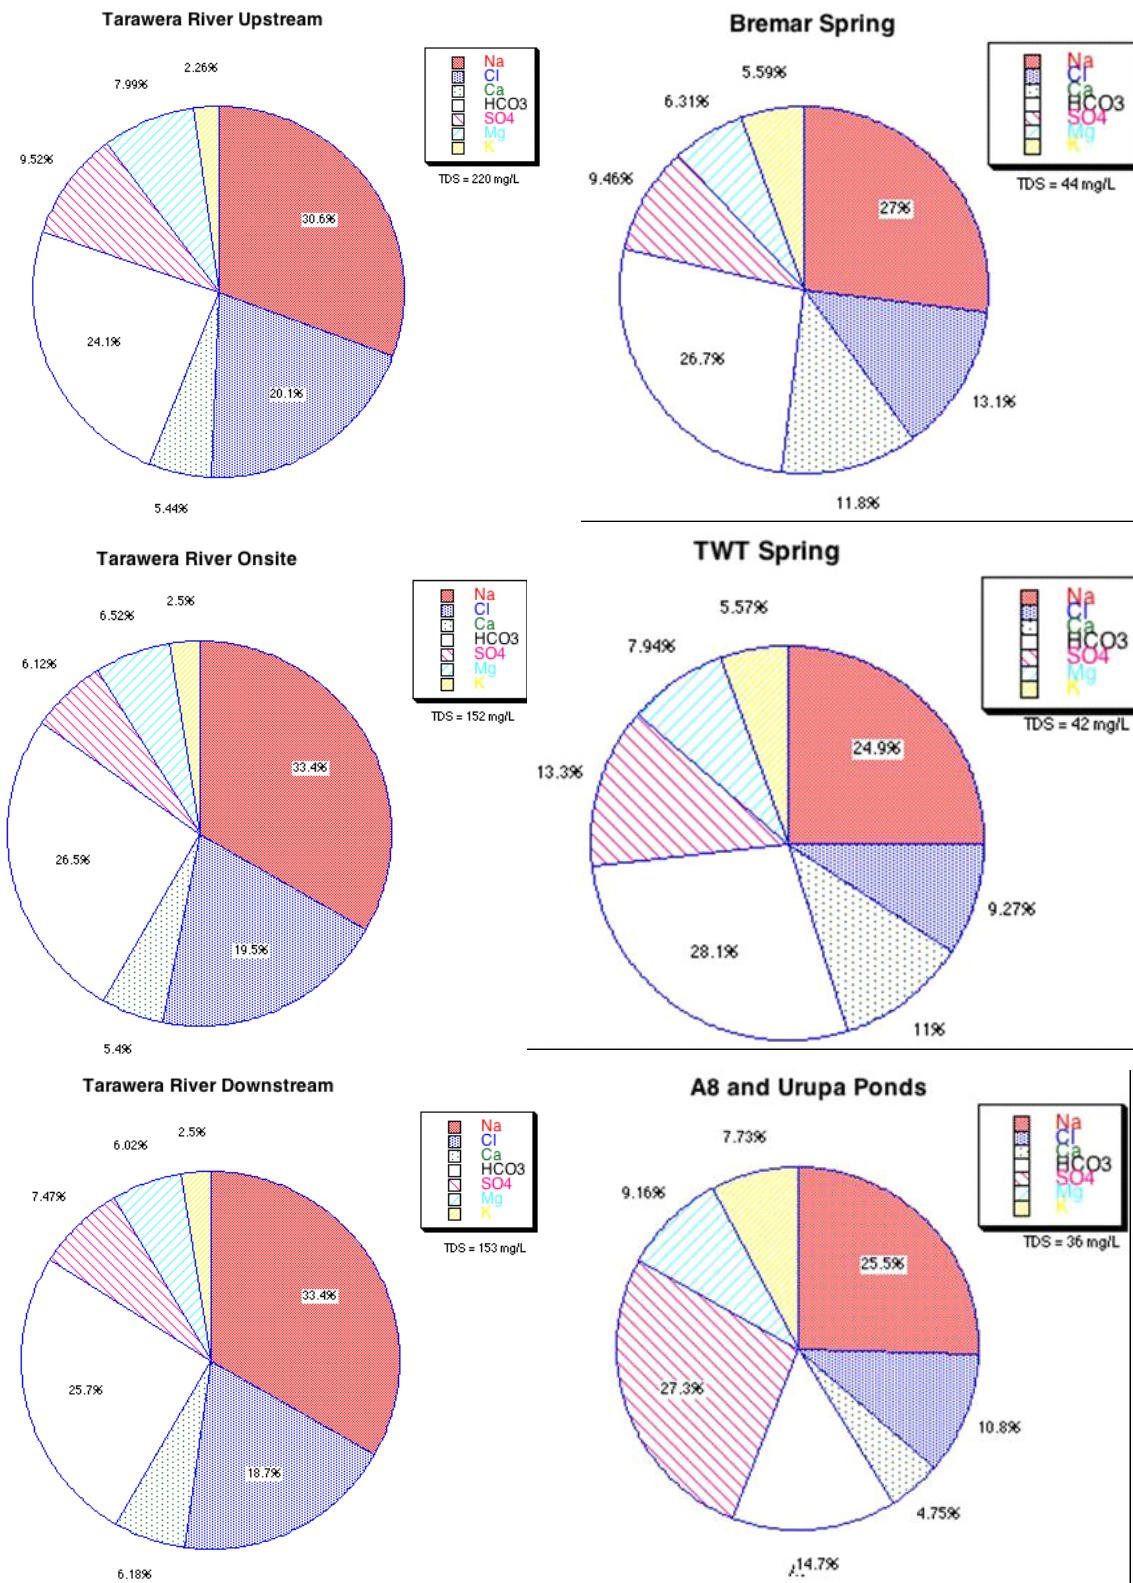
Figure 5. Pie Charts for Tarawera River Upstream, Oniste, and Downstream, Bremar Sprng, TWT Spring, and A8 and Urupa Ponds

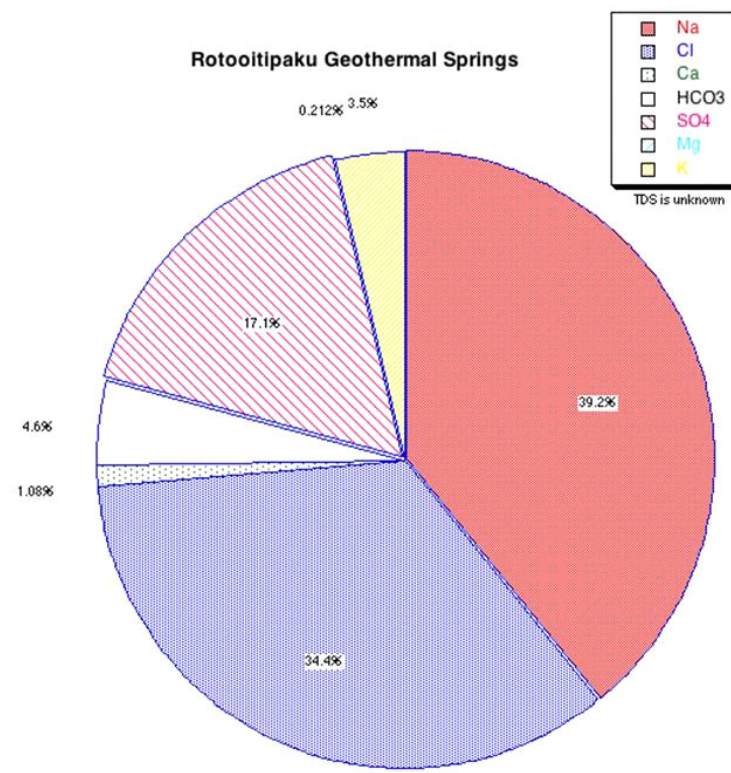
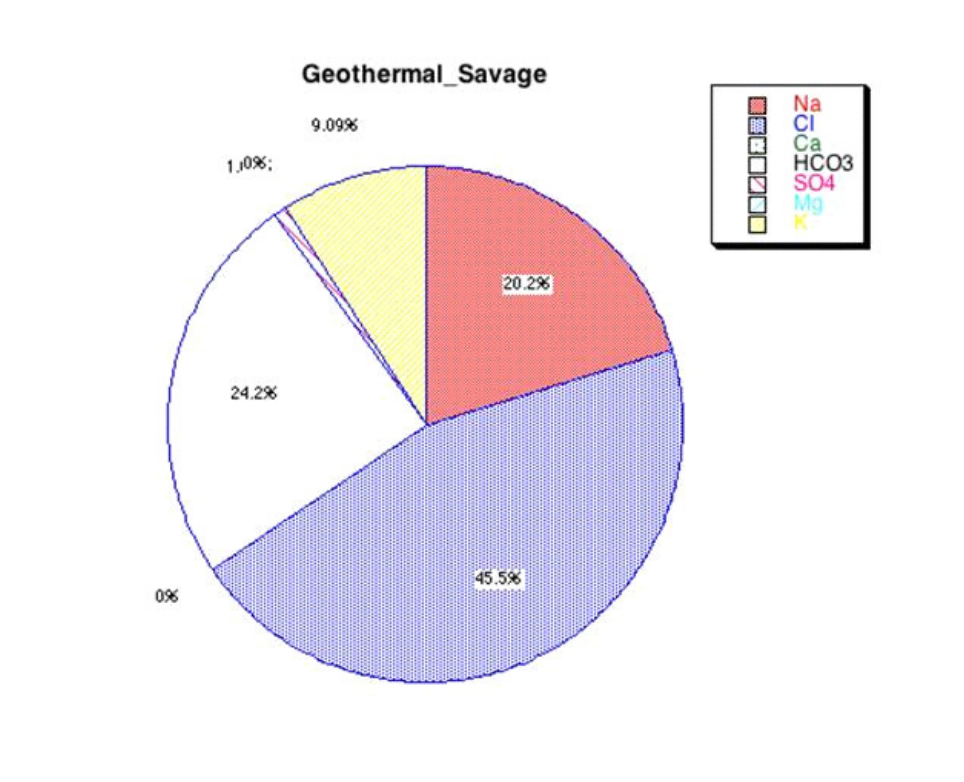
Figure 6. Pie Charts for Rotooitipaku Hot Springs and Savage Pools

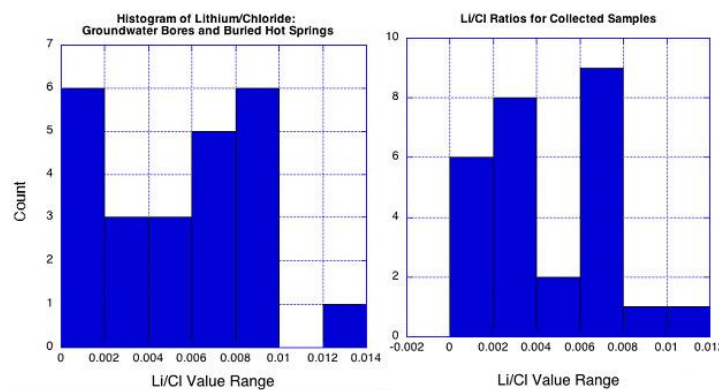
Figure 7a. Histogram of Lithium/Chloride Values for Groundwater Boes and Buried Hot Springs. Figure 7b. Histogram of Lithium/Chloride Values for Collected Samples

SKM (2007) calculated lithium/chloride ratios for a number of onsite groundwater bores and also for the buried hot springs (SKM, 2007). The bores and hot springs are all located on the perimeter or within the primary solids waste disposal area. The lithium/chloride ratios range from 0.0003 to 0.0139 with an average value of 0.0056. The buried hot springs have some of the highest lithium/chloride ratios (~0.008). The Li/Cl ratios from our samples range from 0.00175 to 0.01 with an average value of 0.0044. A histogram of the lithium/chloride ratios for groundwater bores, buried hot springs, and our water samples is shown in Figure 7 below.

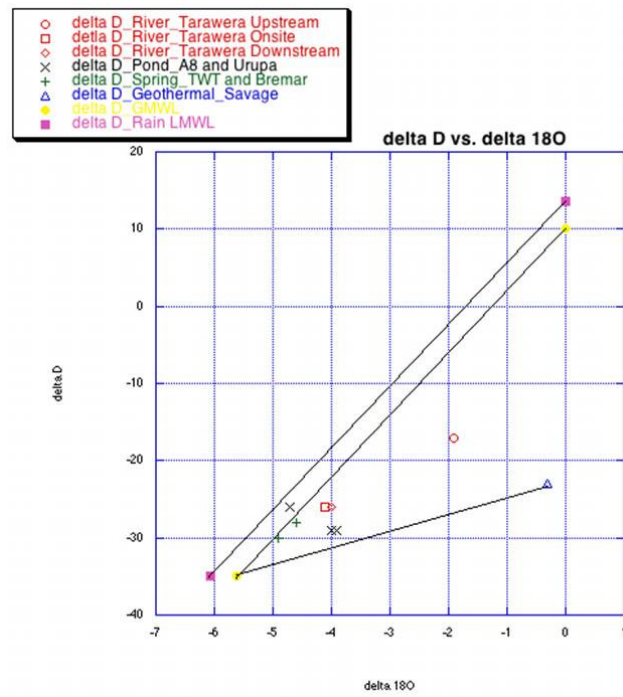
Figure 8. δD versus $\delta 18O$

The theoretical mixing line is illustrated in Figure 8 and is a line extending from a point on the global meteoric water line to for the value of Savage pools (blue triangle). If samples fall

along or close to this theoretical mixing line, one might suggest mixing with geothermal waters. If appropriate, mixing calculations can be performed to determine percent mixing .

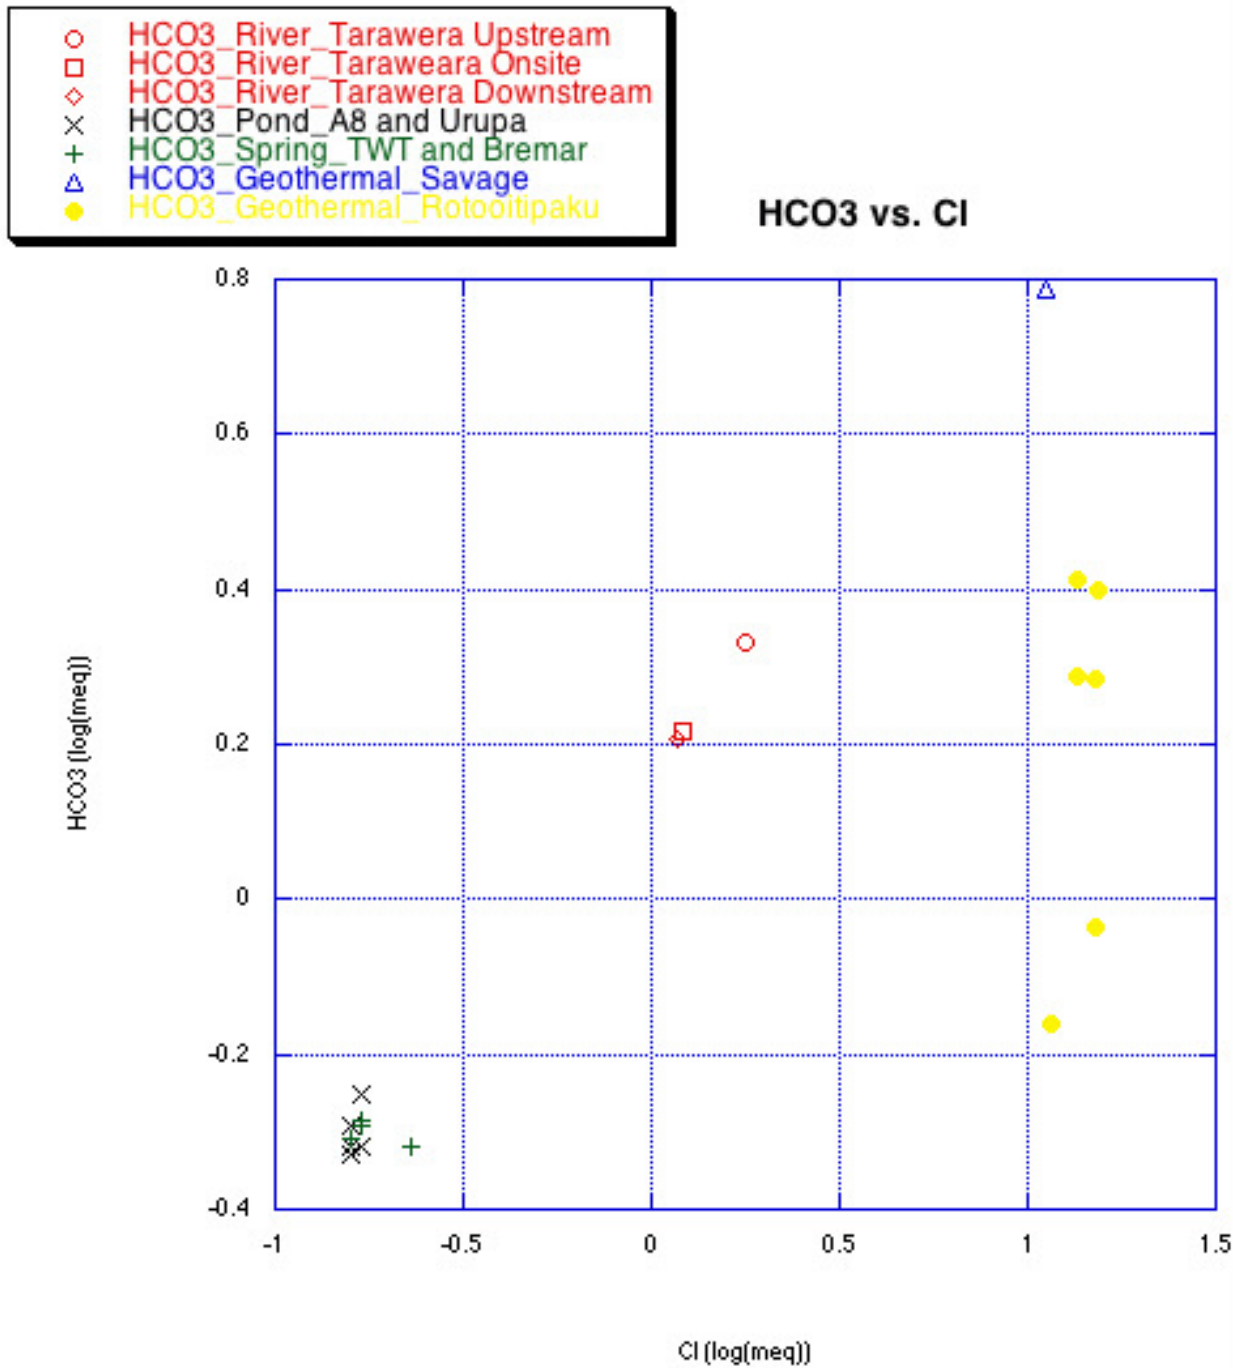
Figure 9. HCO3 (log(meq)) vs. Cl (log(meq))

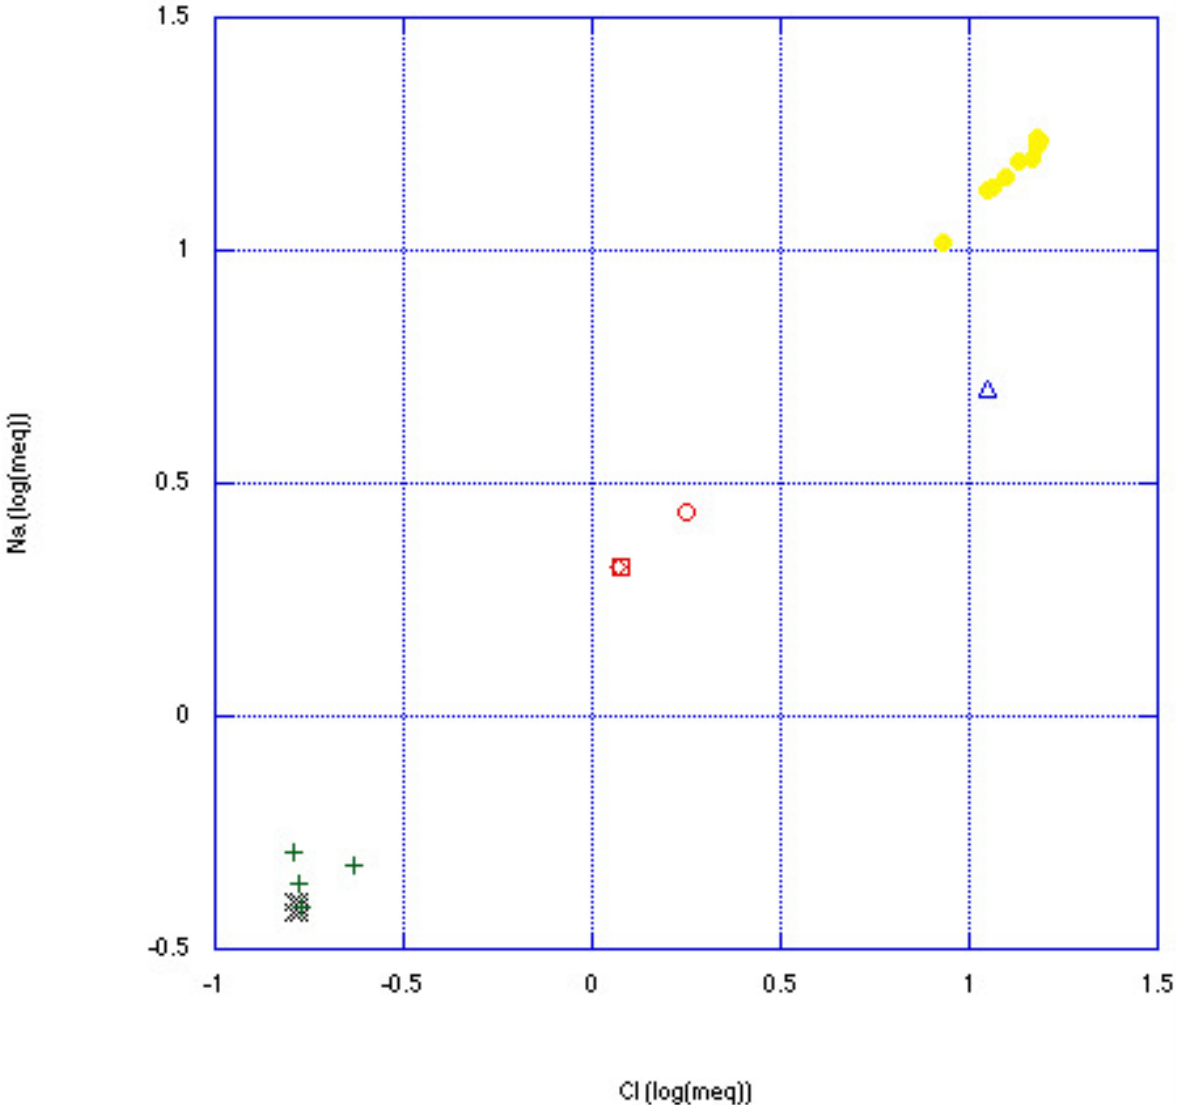
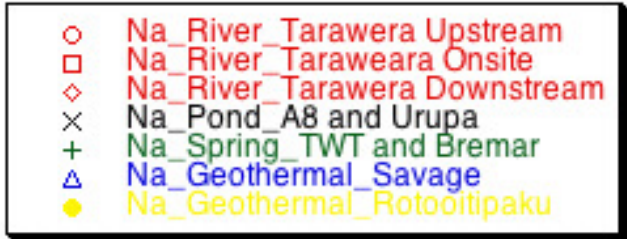
Figure 10. Na (log(meq)) versus Cl (log(meq))

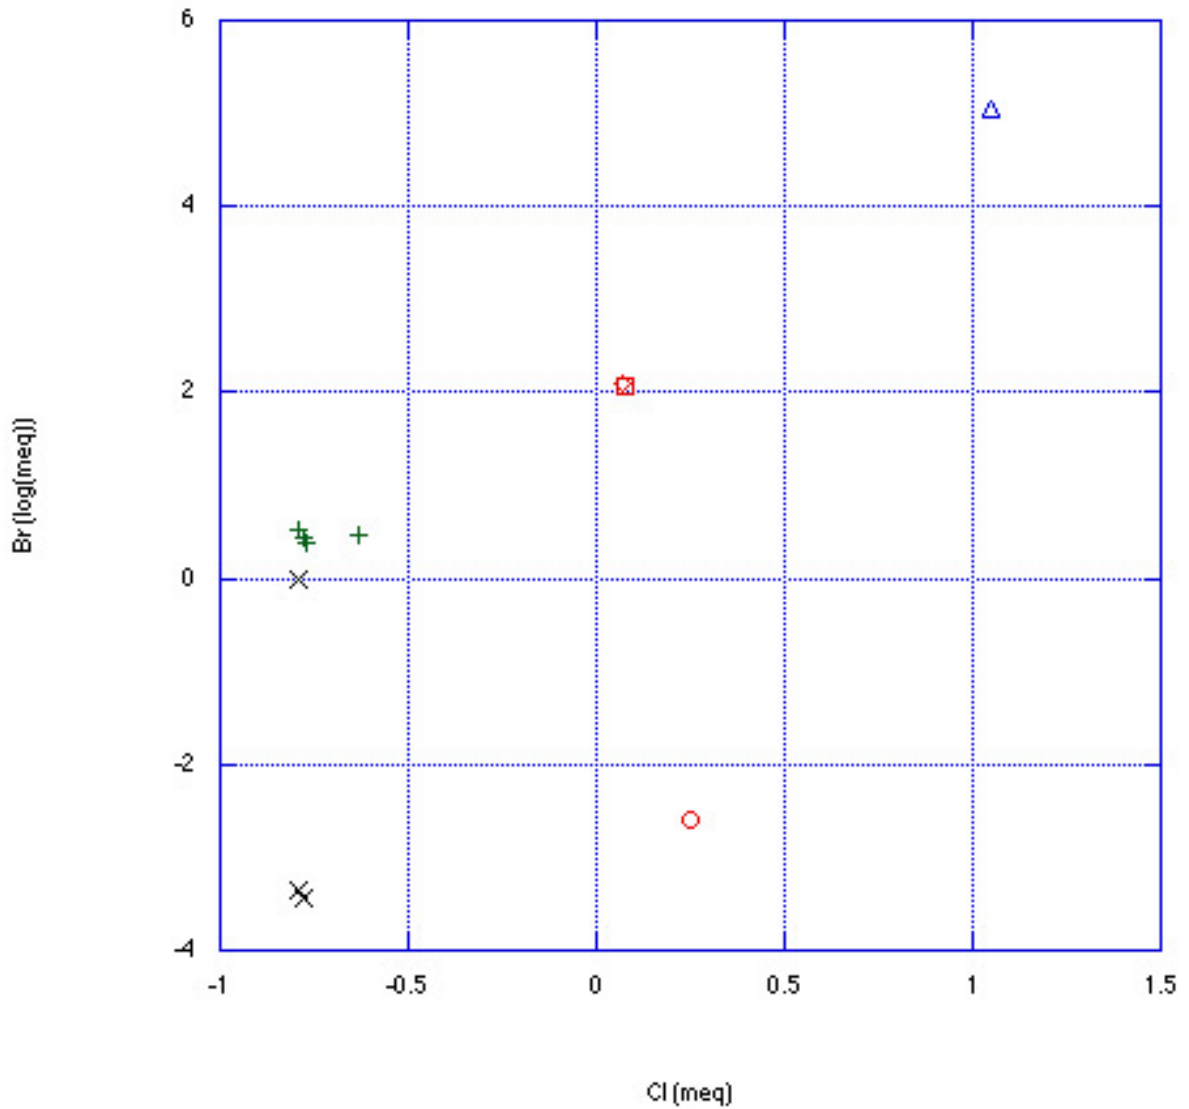
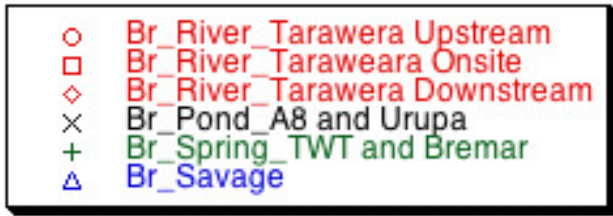
Figure 11. Br (log(meq) vs. Cl (log(meq))

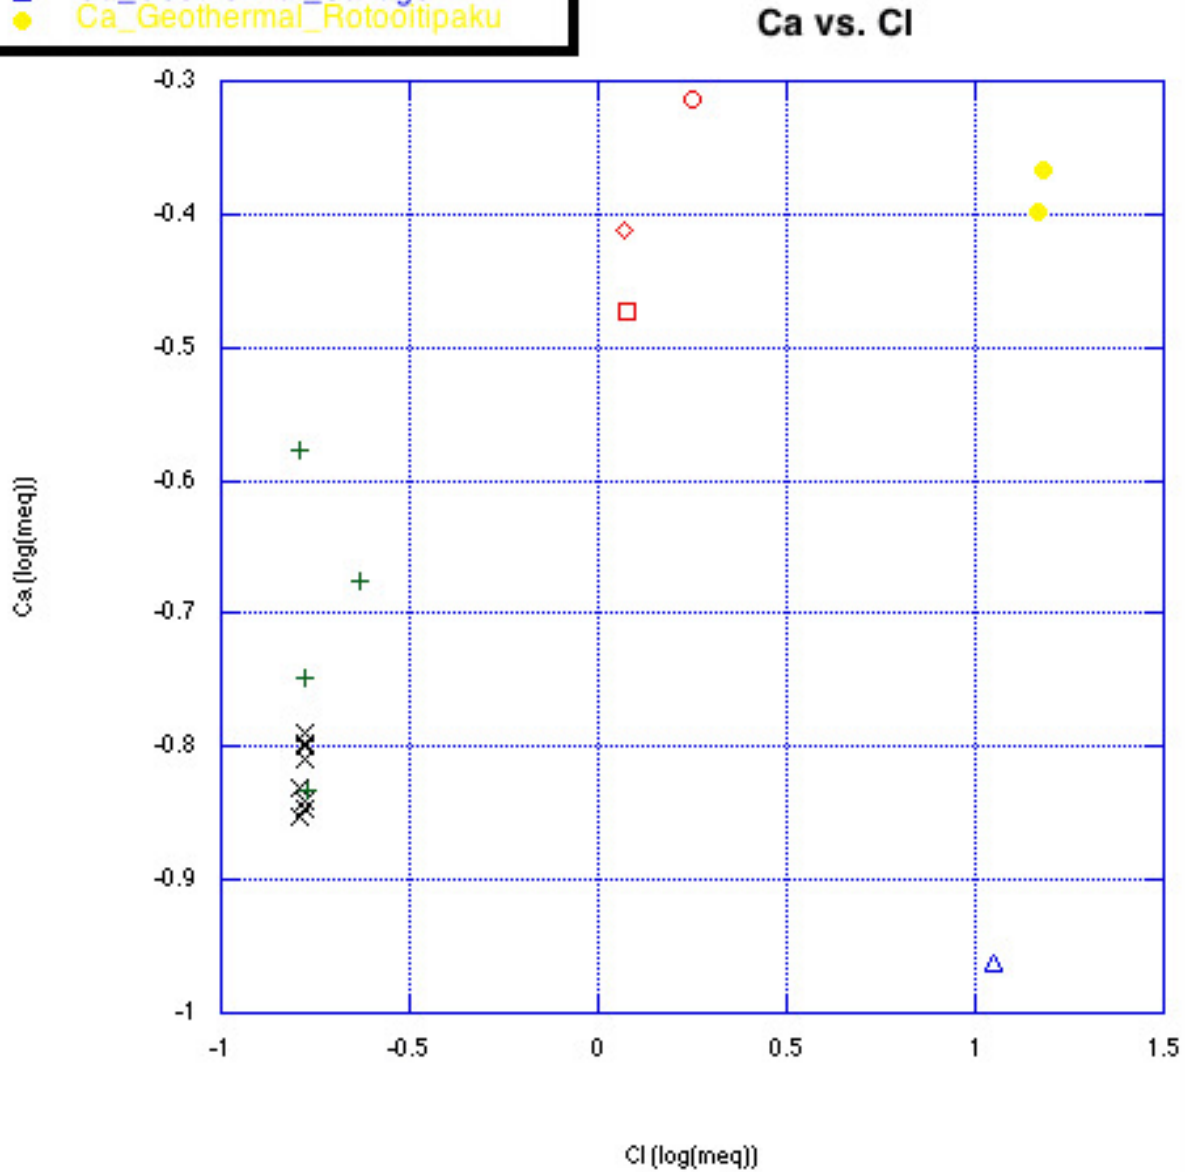
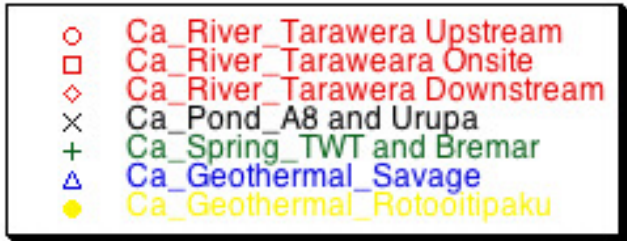
Figure 12. Ca (log(meq)) vs. Cl (log(meq))

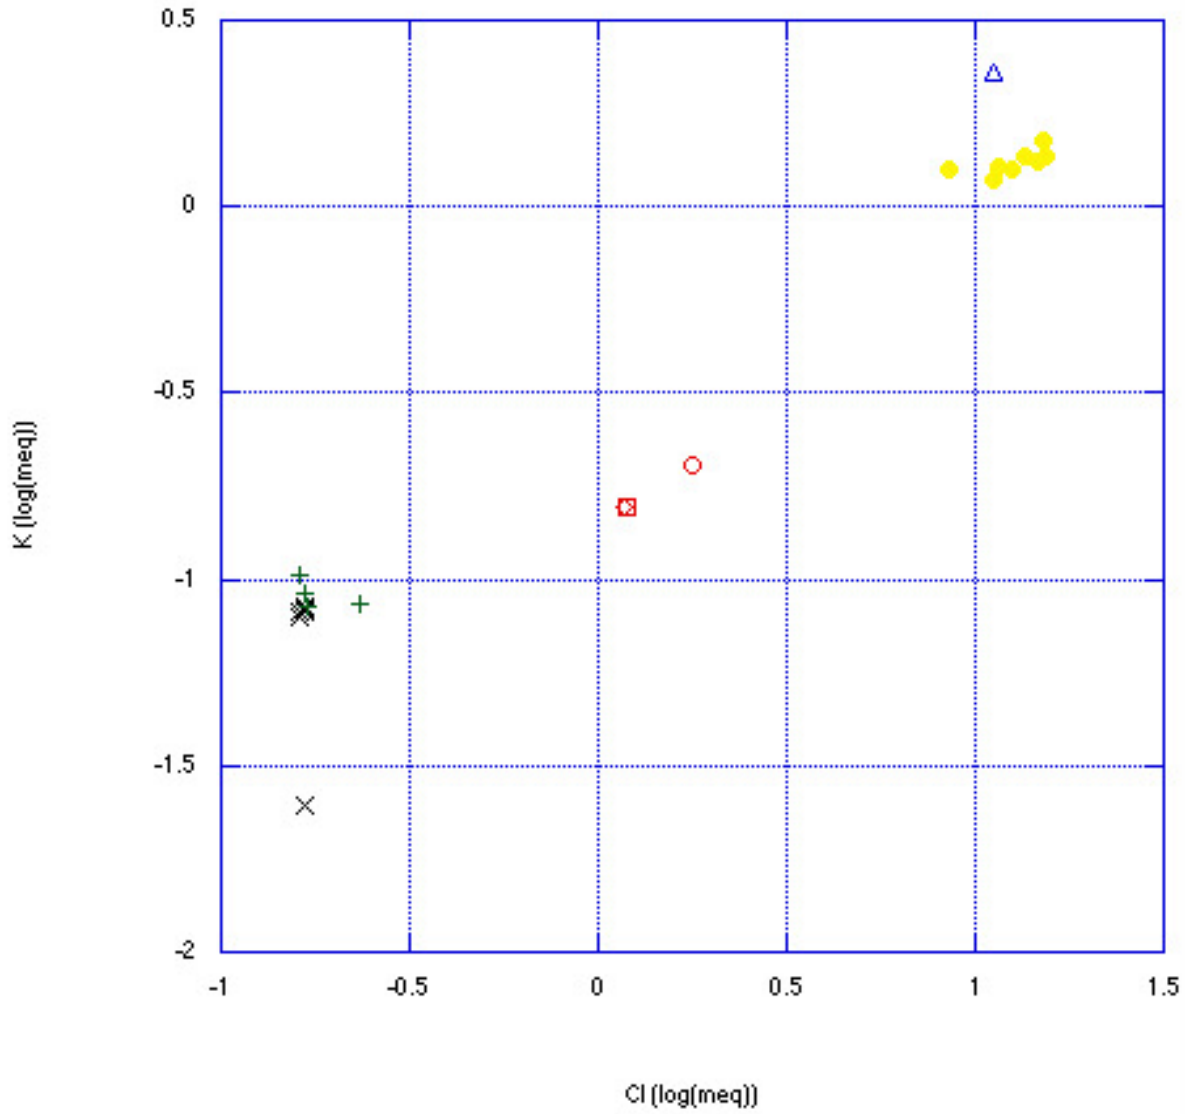
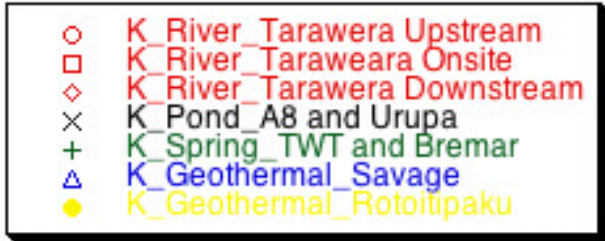
Figure 13. K (log(meq)) vs. Cl (log(meq))

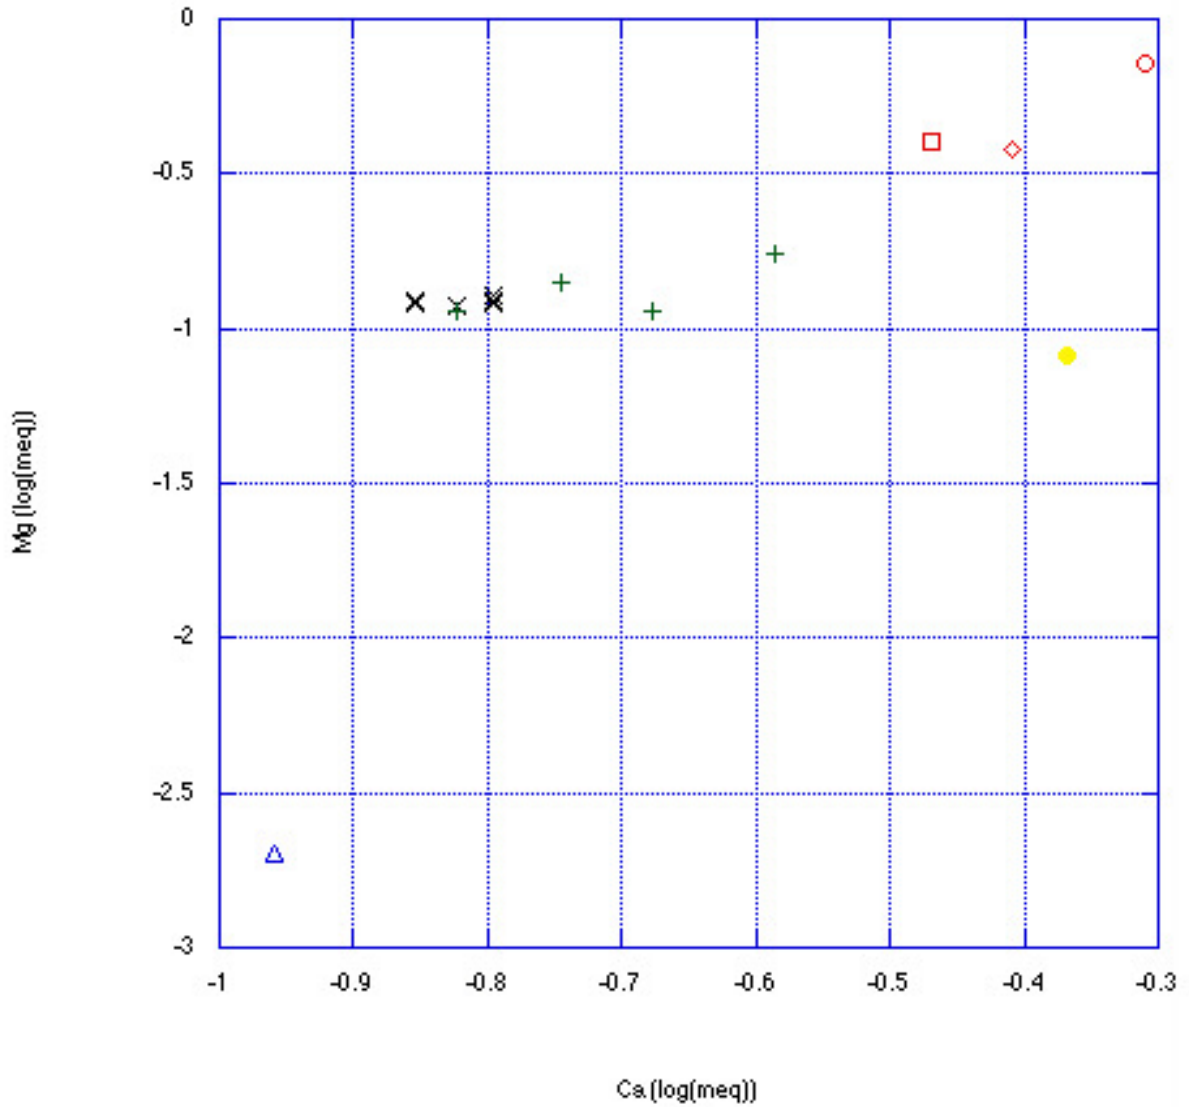
Figure 15. Mg (log(meq)) vs. Ca (log(meq))

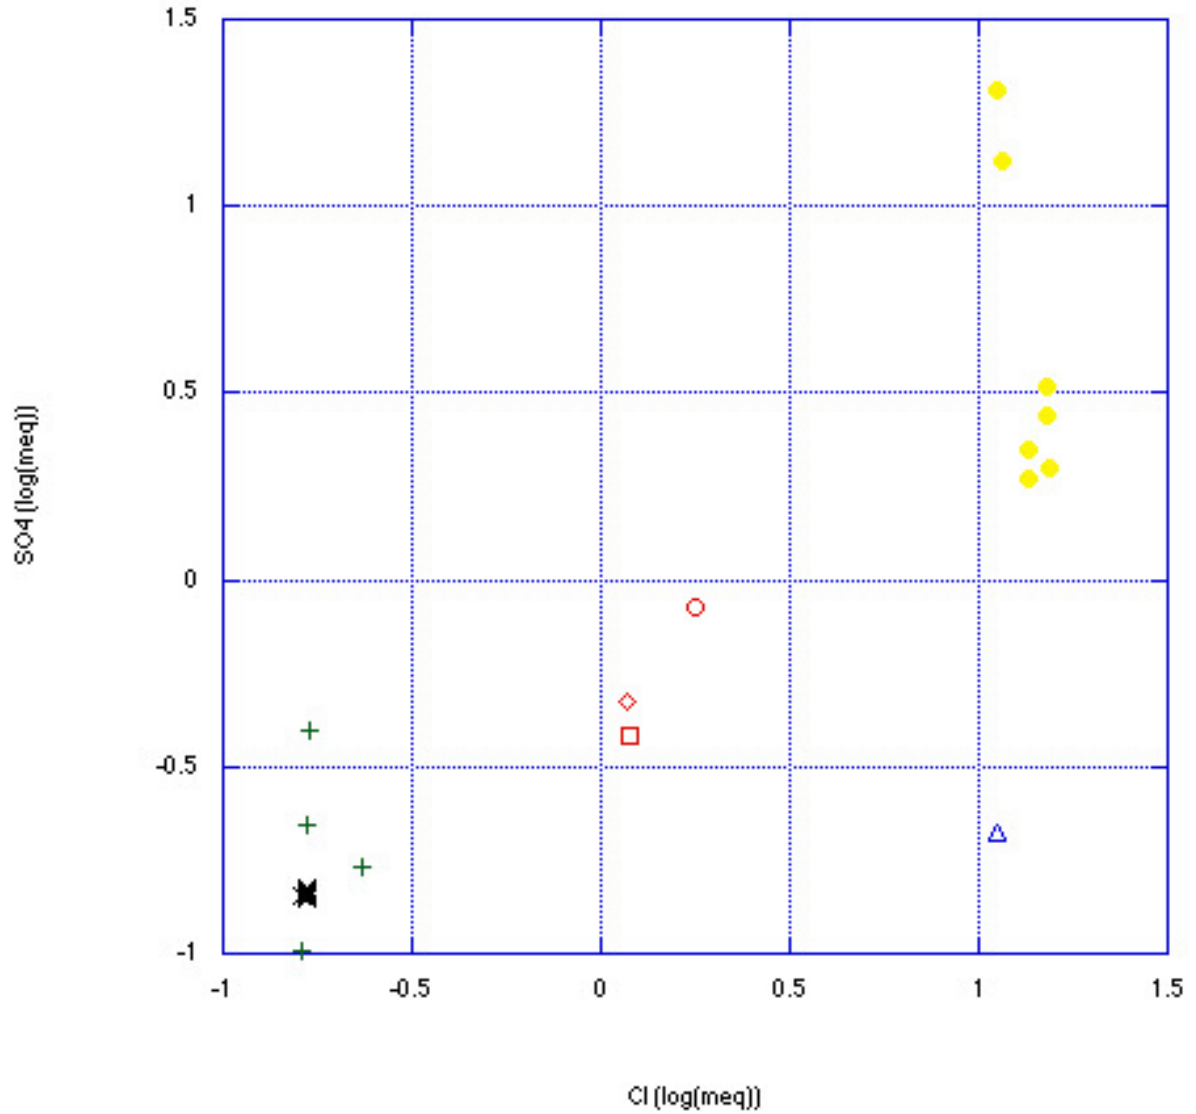
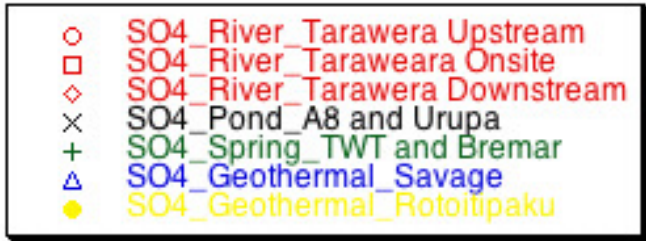
Figure 16. SO4 (log(meq)) vs. Cl (log(meq))
