## **ASSESSMENTS, CONSIDERATIONS AND FITTING OF A TRANS HUMERAL HIGH LEVEL BRACHIAL PLEXUS INJURED INDIVIDUAL WITH HO**

JW 'Bill' Limehouse, CP FAAOP  
Hanger Upper Extremity Prosthetics Program

This talk will discuss the assessment and prosthetic problems associated with fitting an individual with a mid level Trans Humeral amputation.

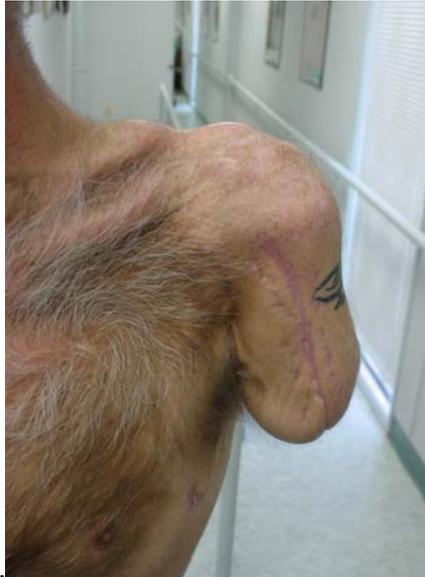
Figure 1 left anterior anatomical view

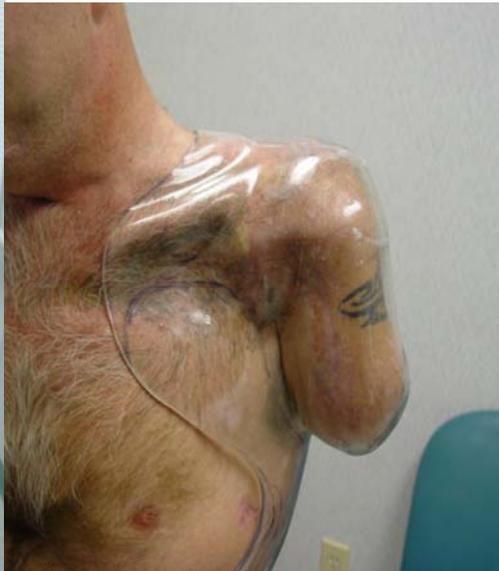
Figure 2 same view test socket

Since there was essentially no functional ROM of the humerus and scapula, myoelectric control was the first consideration. The only functional myo sites were from Rhomboids and Trapezius muscles. An SD type prosthesis was fabricated designed to accommodate the remnant humerus with cutouts to allow the humerus to slide in during donning and doffing. A shoulder joint and Utah 3 elbow with powered wrist and terminal devices were provided.

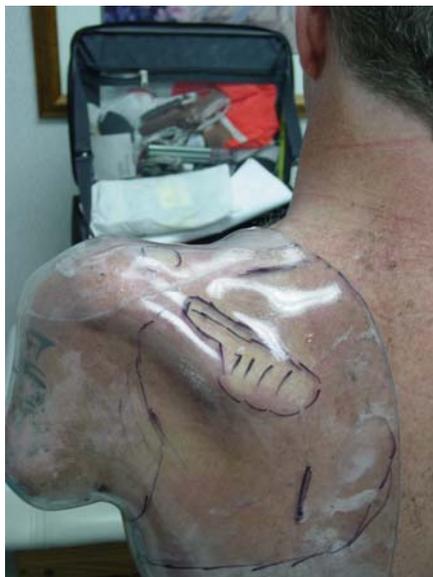
Figure 3 left posterior view test socket

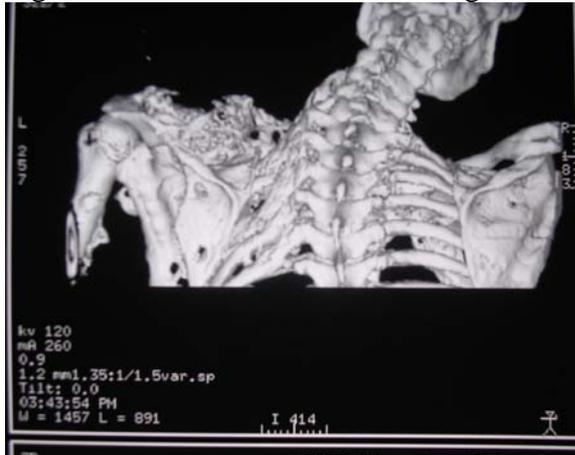
Figure 4 same view 3D CT scan

Physical examination revealed he had a severe involvement of HO of the upper torso, neck and left shoulder. The patient brought in a copy of his 3D CT scan. This showed all of the HO involvement along the chest, spine, shoulder and neck. There was a lot of associated pain in and around the shoulder, neck and torso.

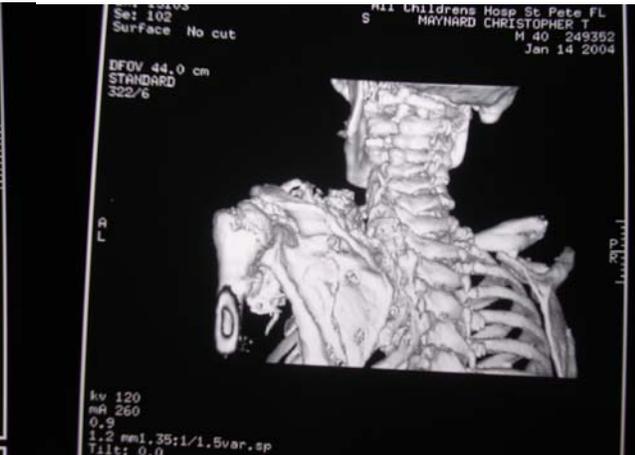
Figure 5

Figure 5-6 posterior 3D CT scans
